Optimization Review Report Operation and Maintenance Optimization Study

**Reynolds Metals Company Superfund Site
Multnomah County, Oregon
EPA Region 10**

REYNOLDS METALS COMPANY SUPERFUND SITE, MULTNOMAH COUNTY, OREGON EPA REGION 10

FINAL REPORT
September 2018

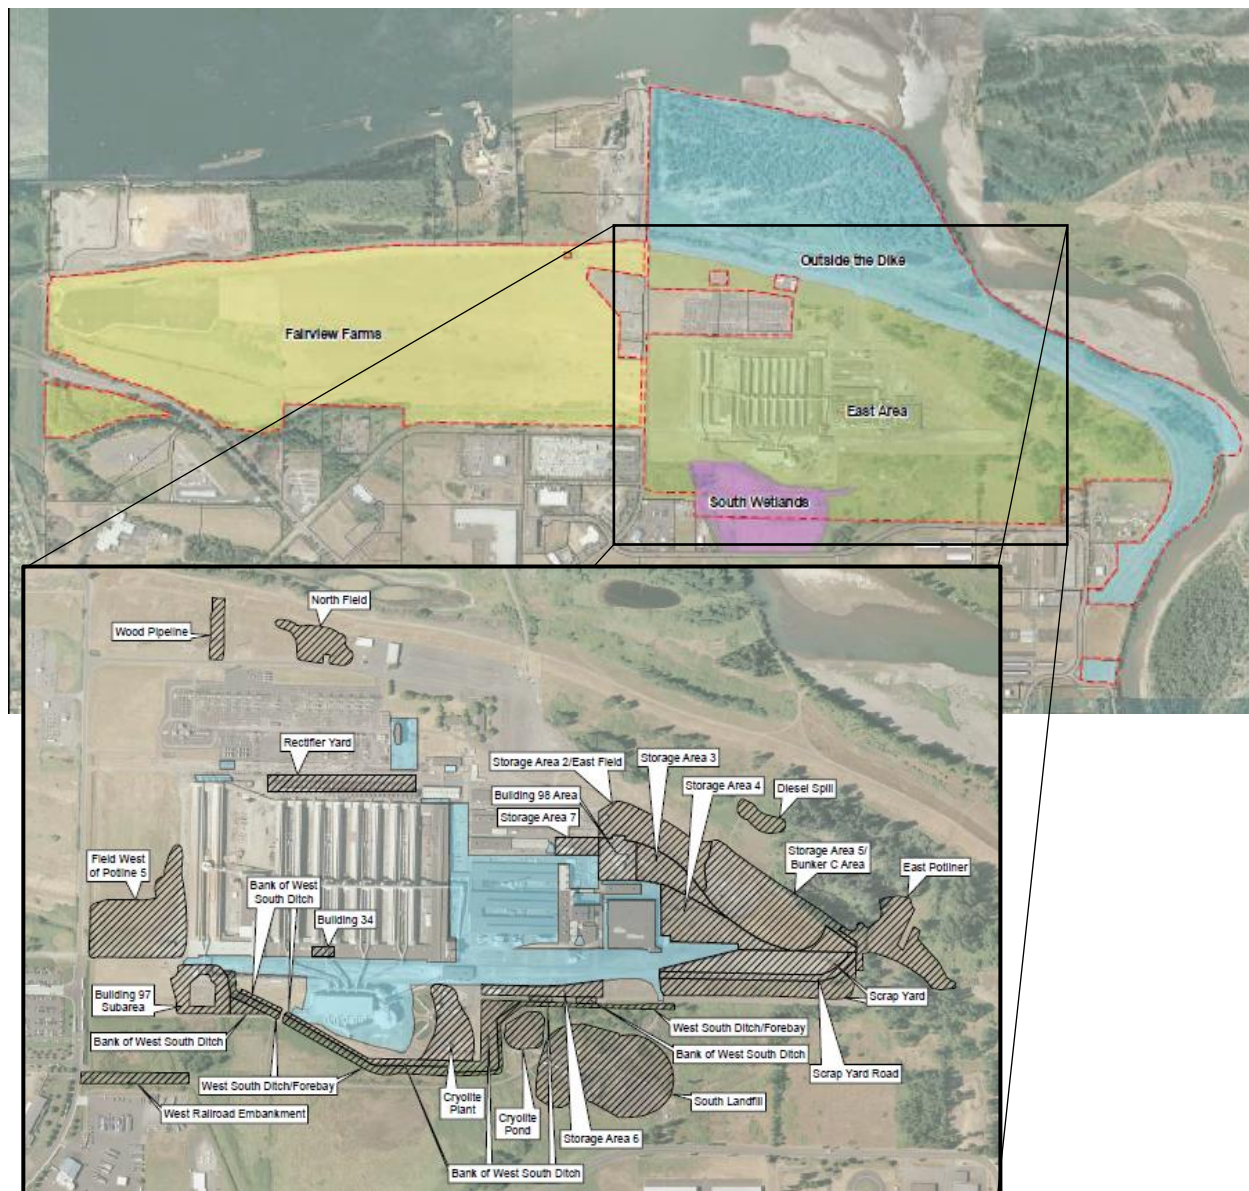
According to the second Five-Year Review (EPA, 2013), the Remedial Investigation and Feasibility Study (RI/FS) showed there were high levels of contamination in soil, waste, and debris and in North Landfill, South Landfill, the Scrap Yard, and East Potliner area. The North Landfill is located north of the USACE dike. The South Landfill, Scrap Yard, and East Potliner area are all located in the East (Former Plant) Area shown in Figure 1. High levels of contamination were also identified in the process residue that was located at the bottom of Company Lake. A fluoride plume is present in groundwater beneath the RMC facility. The contaminated materials in these waste areas were considered to be the primary sources of groundwater contamination.

Figure 1: RMC site layout and potential former East Area source areas (EPA, 2006). All figures reproduced in Appendix B.]

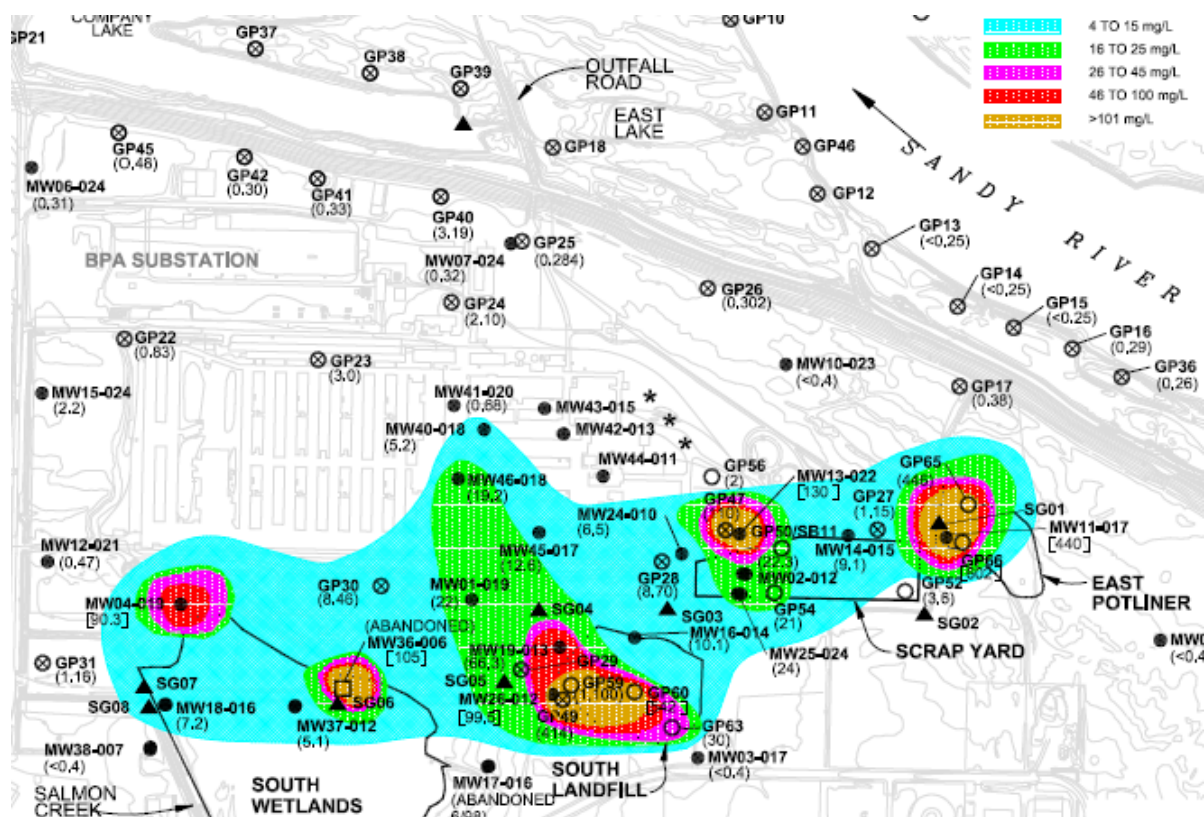
These areas are depicted in the Figure 1. Based on the fluoride concentrations in shallow groundwater depicted in the ROD (see Figure 3), the following areas appear to have been substantial sources of fluoride contamination to groundwater:

Although the above concentrations may be protective with respect to human direct contact exposure pathways, the residual fluoride, if sufficiently leachable from soil, may be serving as an ongoing source of contamination via leaching to groundwater. The contamination within the silt unit is also serving as an ongoing secondary source of fluoride contamination to the underlying sands.

Figure 3: 1997/1998 fluoride concentrations in the silt unit, indicating historical sources of fluoride contamination. The color scale reflects the fluoride concentration (EPA, 2006). All figures reproduced in Appendix B.]

- Fluoride contamination in the silt unit is limited to source areas in the former process area and generally extend across the known extent of the silt unit to the northwest. (See Figure 3)

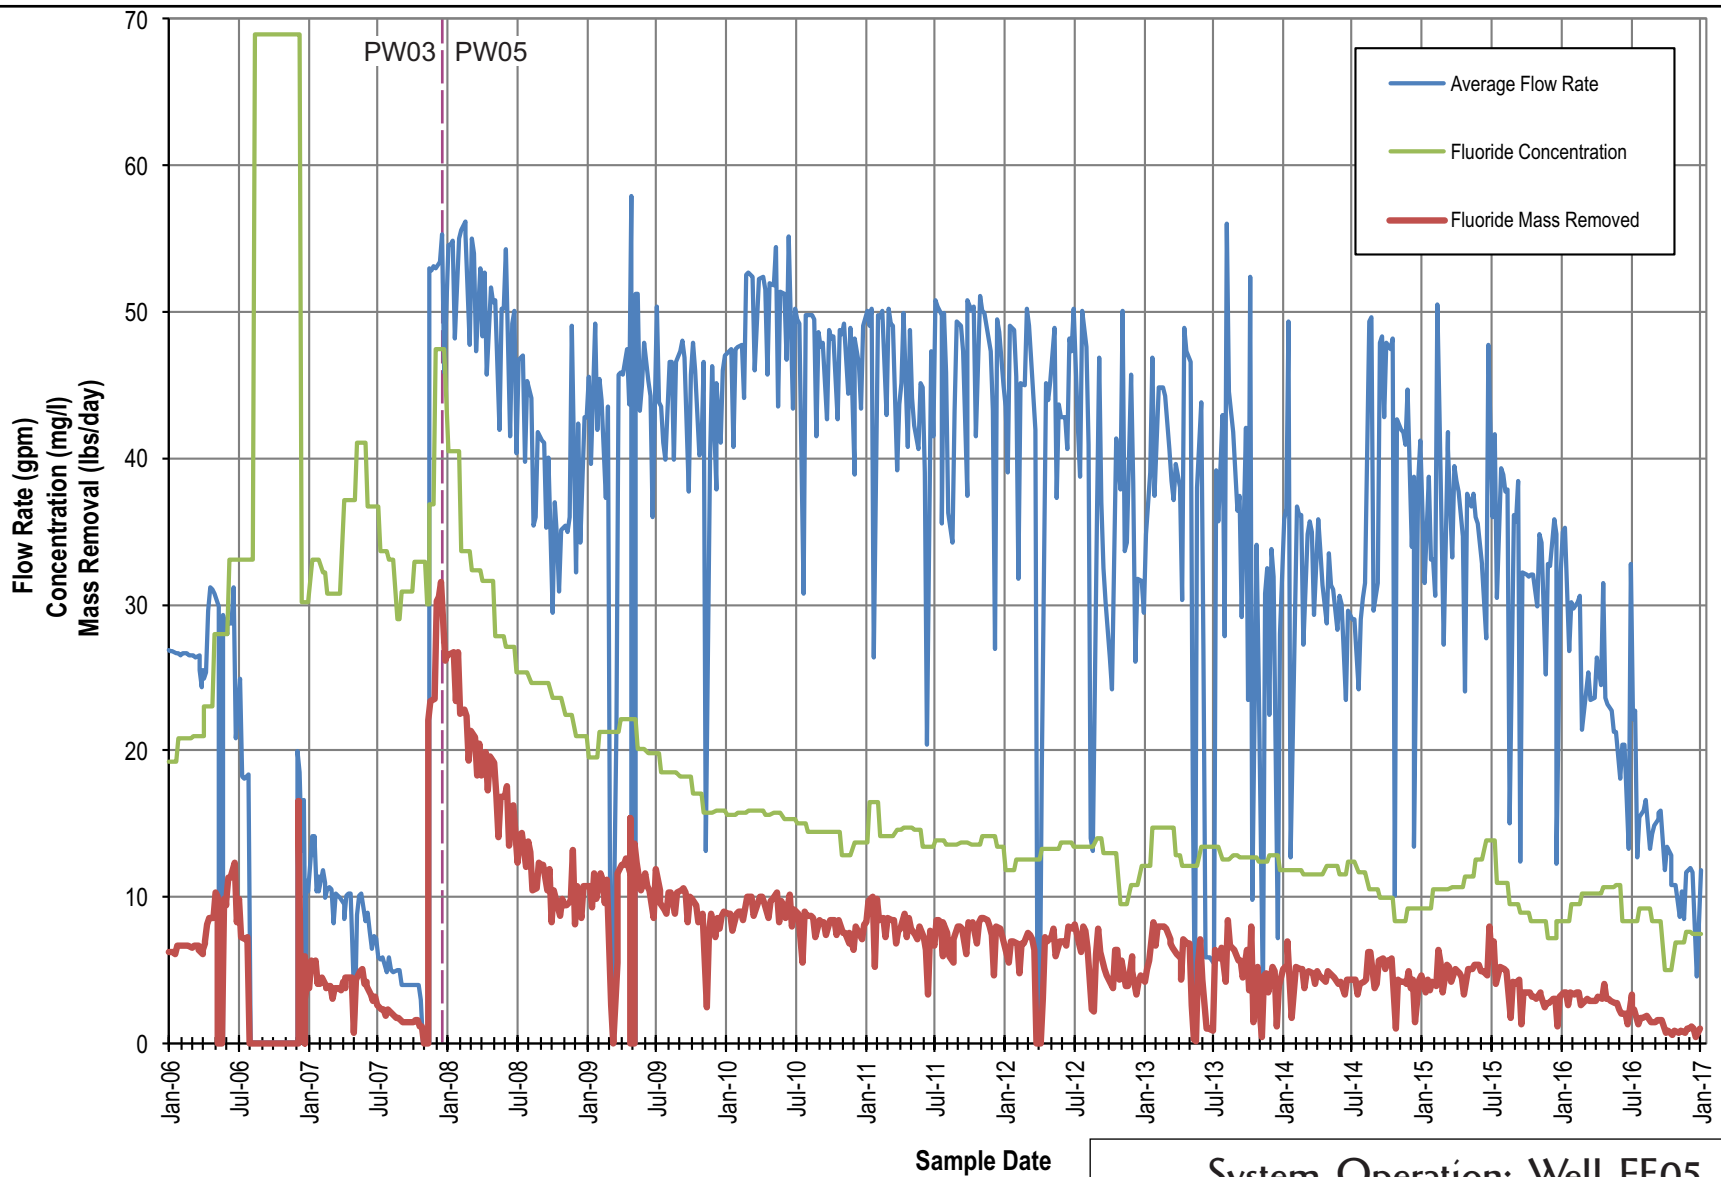
Referring to Figure 29 from the 2016 Annual Report (APEX, 2017), the cumulative mass removal from FE03/05 shows flattening of the curve at approximately 25,000 pounds, suggesting that the mass removal rate has decreased significantly. Review of Figure 26 of the 2016 Annual Report (APEX, 2017), also provided in Appendix B, shows that both the concentration and the flow rate have also decreased over time. The FE05 influent concentration is approximately 9 mg/L, which is relatively low compared to the 100 mg/L concentration in nearby well MW34-038, suggesting that FE05 is also extracting clean water because it may no longer be located within the core of the fluoride plume.

System Operation: Well FE05

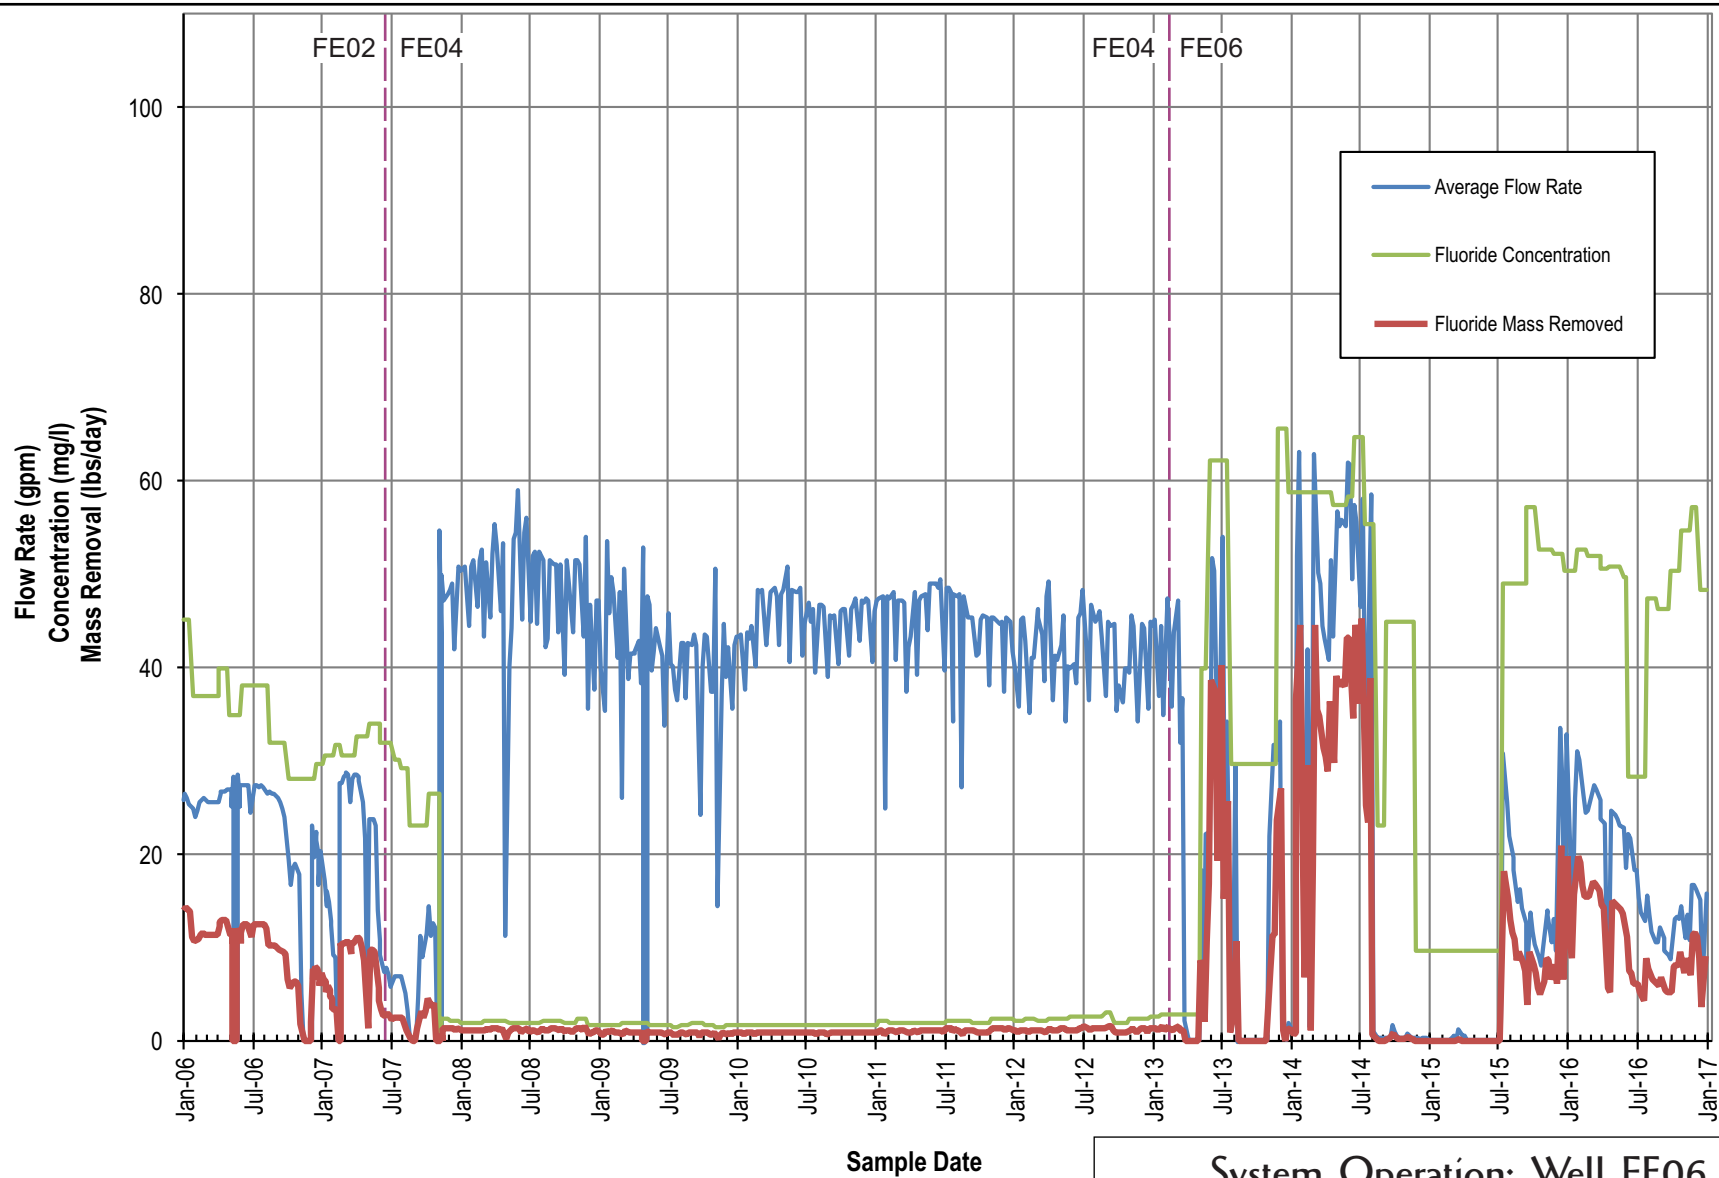
- The FE component of the system involves extraction from two focused extraction wells (FE wells) in the upper gray sand near the Scrap Yard. Up to five FE wells have been used for this purpose since the remedy began. At the time of the optimization review, FE05 and FE06 were in operation. These wells were originally capable of maintaining extraction rates over 40 gallons per minute (gpm), but the extraction rates have decreased over time due to fouling and plugging of the wells or conveyance piping. Previous FE wells FE01, FE02, and FE03 also were impacted by fouling or scaling. The operational history of these well is graphically displayed in Figures 26 and 27 from the 2016 Annual Report (APEX, 2017), which are provided in Appendix B. The fluoride concentration on FE05 was decreased to under 10 mg/L. The fluoride concentration in FE06 remains above 40 mg/L. (See Figure 2 for FE well locations.)

System Operation: Well FE06

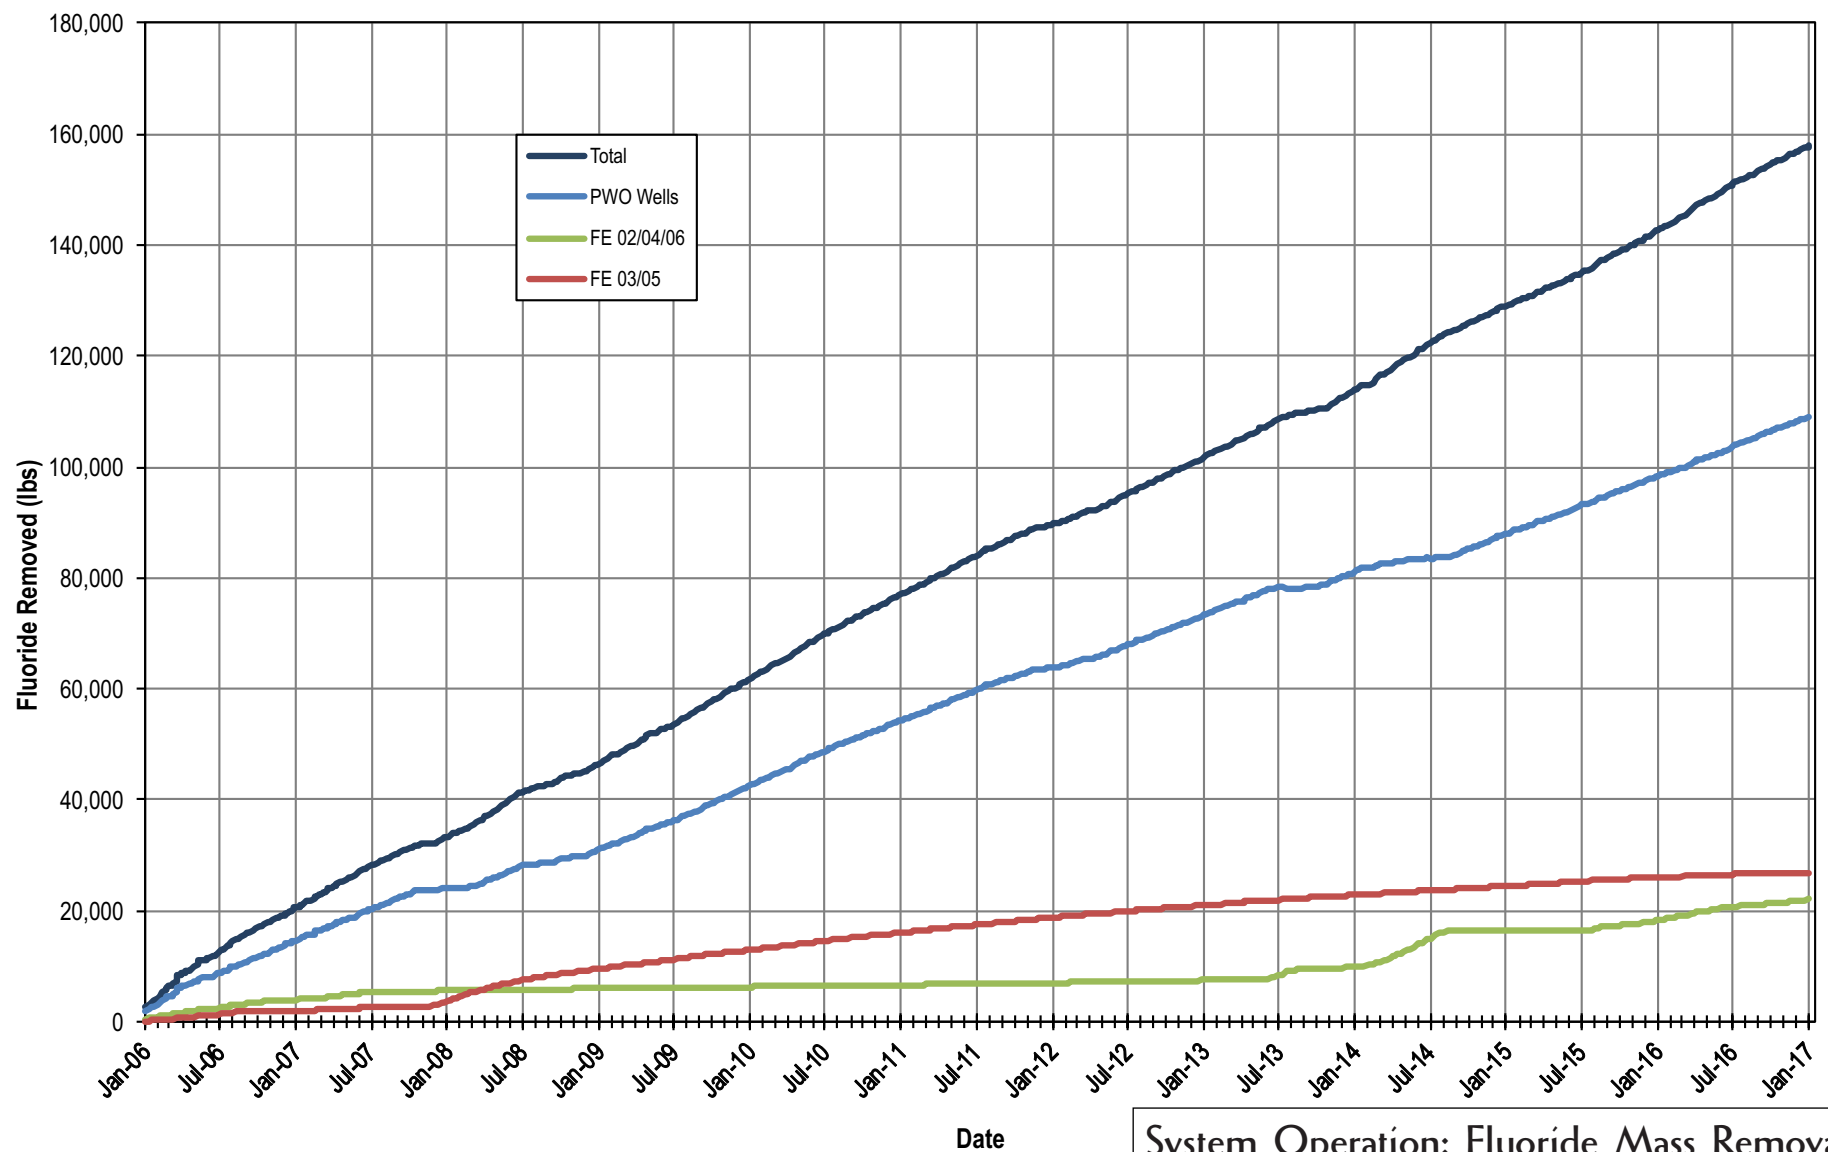
System Operation: Fluoride Mass Removal

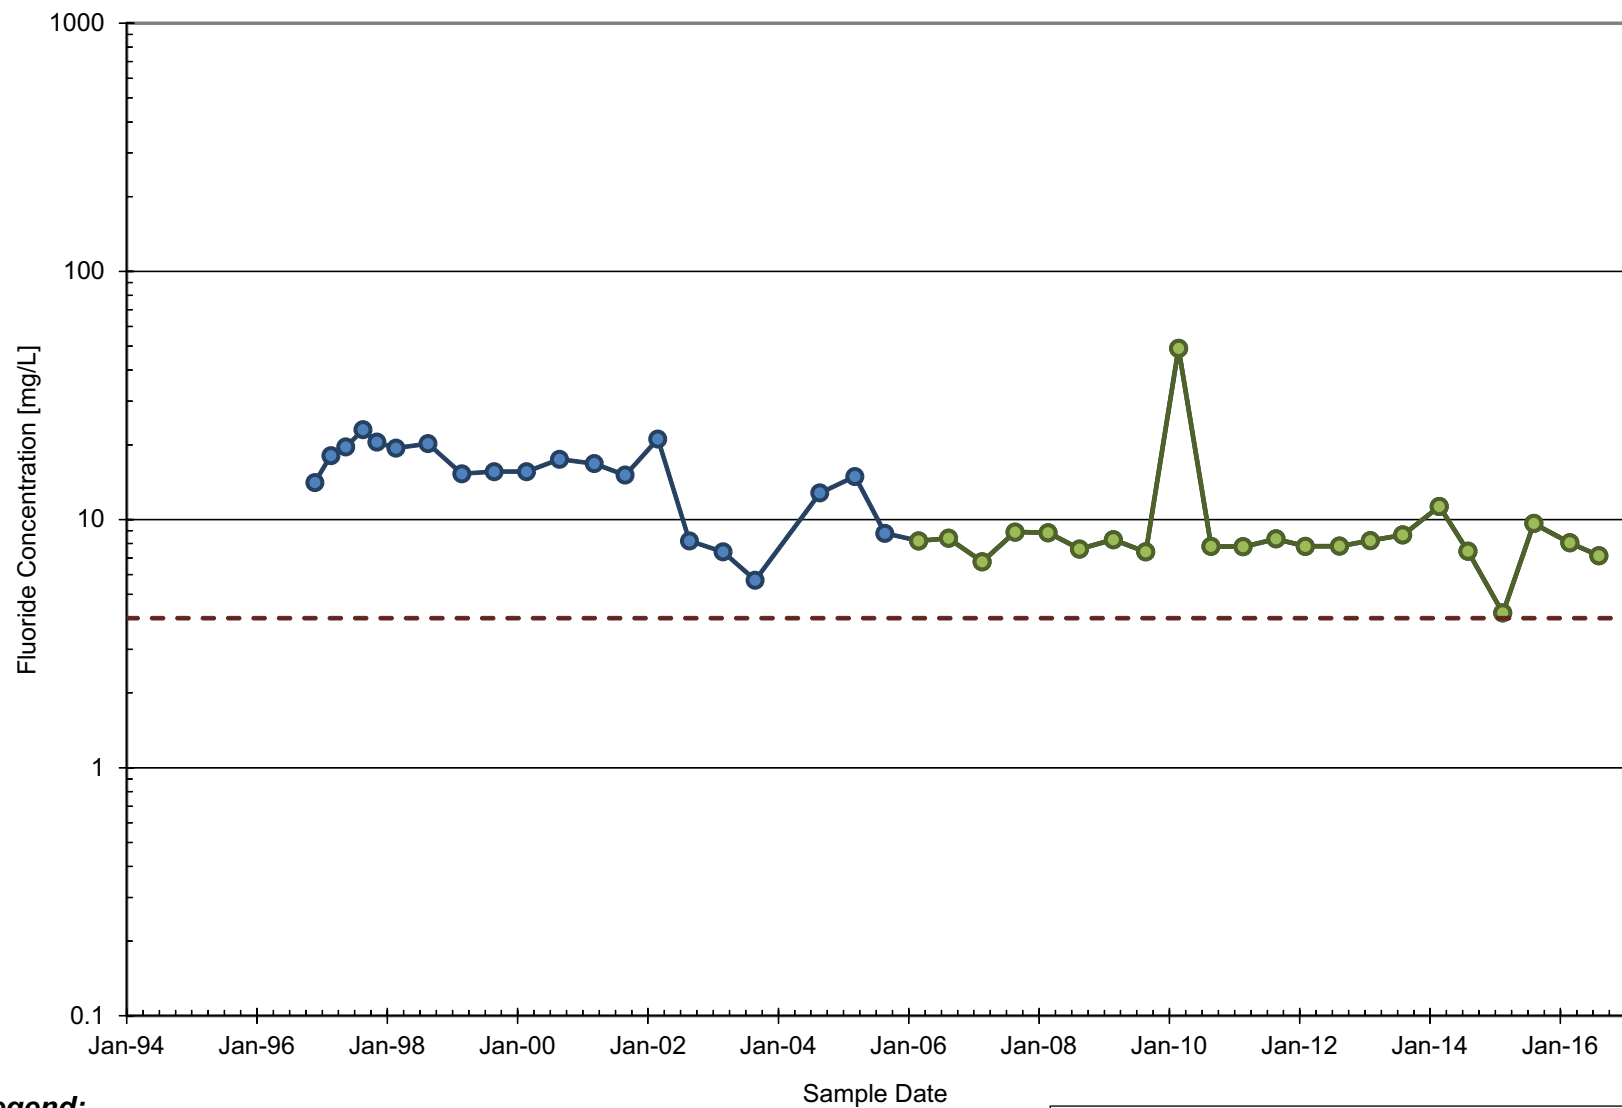
- South Landfill: The upper gray sand near the South Landfill is also poorly characterized by monitoring wells near the South Landfill source area. The one monitoring well in the area (MW26-50) has had a decreasing fluoride concentration trend and the fluoride concentration is now consistently below 1 mg/L. Higher concentrations may be present in the upper gray sand in the vicinity of silt unit well MW19-13 because this location is downgradient of the upper gray sand contamination historically observed at GP59. The concentration decreases at MW26-050 may be the result of the contamination being pulled to the east (rather than being depleted) due to operation of the FE/PWO system. ODEQ reports that the February and September 2017 concentrations were 13.9 mg/L and 7.3 mg/L, respectively, supporting the conceptual model that the recent decreased concentrations reflect contaminant redistribution rather than contaminant removal.

<h3 style="margin: 0;">Fluoride Concentration Trend: MW26-050</h3> <p style="margin: 0;">Troutdale Reynolds Industrial Property - 2016 Annual Report Port of Portland Troutdale, Oregon</p>						
<p style="font-size: 0.8em; margin: 0;">Apex Companies, LLC 3015 SW First Avenue Portland, Oregon 97201</p>	<table border="1" style="width: 100%; border-collapse: collapse;"> <tr> <td style="width: 50%; padding: 2px;">Project Number</td> <td style="width: 50%; padding: 2px;">1069-70</td> </tr> <tr> <td colspan="2" style="padding: 2px;">January 2017</td> </tr> </table>	Project Number	1069-70	January 2017		<p style="font-size: 0.8em; margin: 0;">Figure</p> <h2 style="margin: 0;">B-23</h2>
Project Number	1069-70					
January 2017
